Structural Response Analysis of Experimentally Tested Aluminum Cracked Panels under Compressive Load

An experimental investigation is carried out to evaluate the ultimate compressive capacity of welded stiffened aluminum panels in alloy 5083-H116 subjected to uniaxial compressive load along the short edge. A tensile test is carried out to find out the real material properties. Five full-scale stiffened panel specimens, one of them is intact and locked cracks are produced in the other four panels. A global survey of the initial geometric imperfections is performed before conducting the compressive test. Through-thickness-locked cracks are located either in the center or quarter of the plate between the two attached stiffeners. The panels are tested, and their progressive collapse behavior is reported. The panels failed by two different deformation modes: stiffener tripping and local buckling of the plate. The load-shortening and load-lateral displacement relations are presented, and concluding remarks are stated regarding the effect of locked crack's location, orientation, and initial imperfection on the compressive capacity of welded aluminum panels.

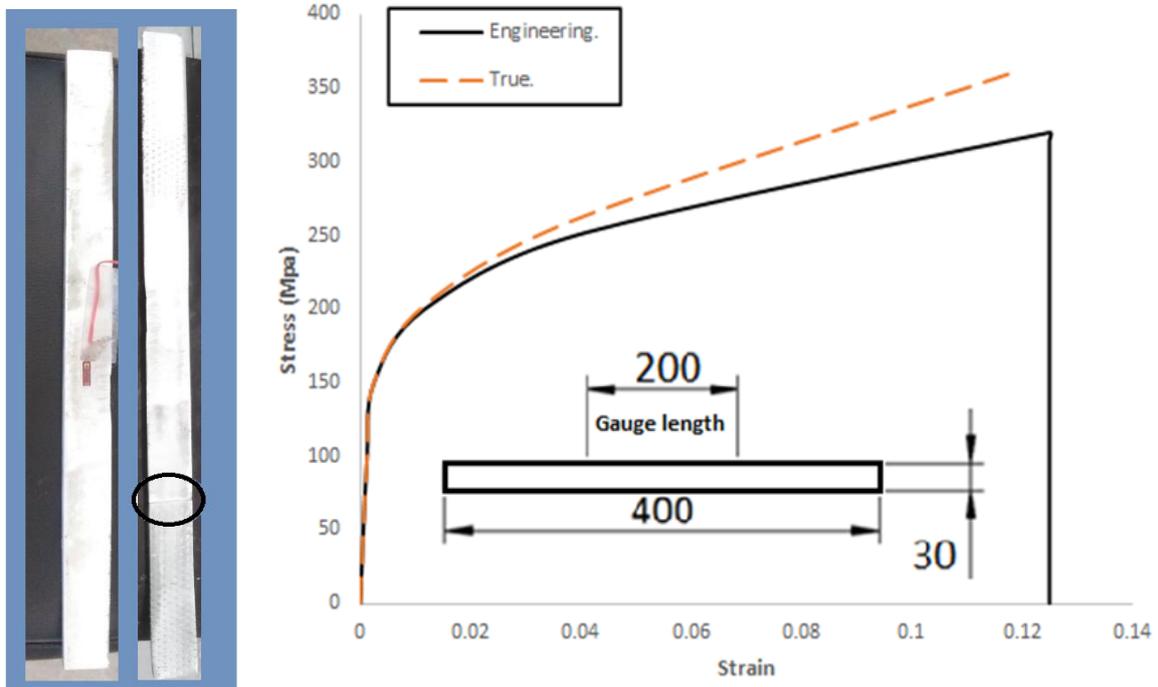
Figure 1: A rectangular tested coupon (left) and engineering and true stress-strain relationship (right)

The used material in this study is aluminum alloy 5083-H116. A tensile test is carried out on a rectangular test coupon (400x30x6 mm) with gauge length of 200 mm as shown in Figure 1 (left) to obtain the actual mechanical properties of the material. A strain gauge is fitted in the mid of the test coupon, see Figure 1(left), to obtain accurate strain values during the test. The engineering stress-strain and the true stress- strain curves are plotted in Figure 1 (right). The values of the true stress and true strain can be derived in terms of the engineering stress and engineering strain using the following equations [15]:

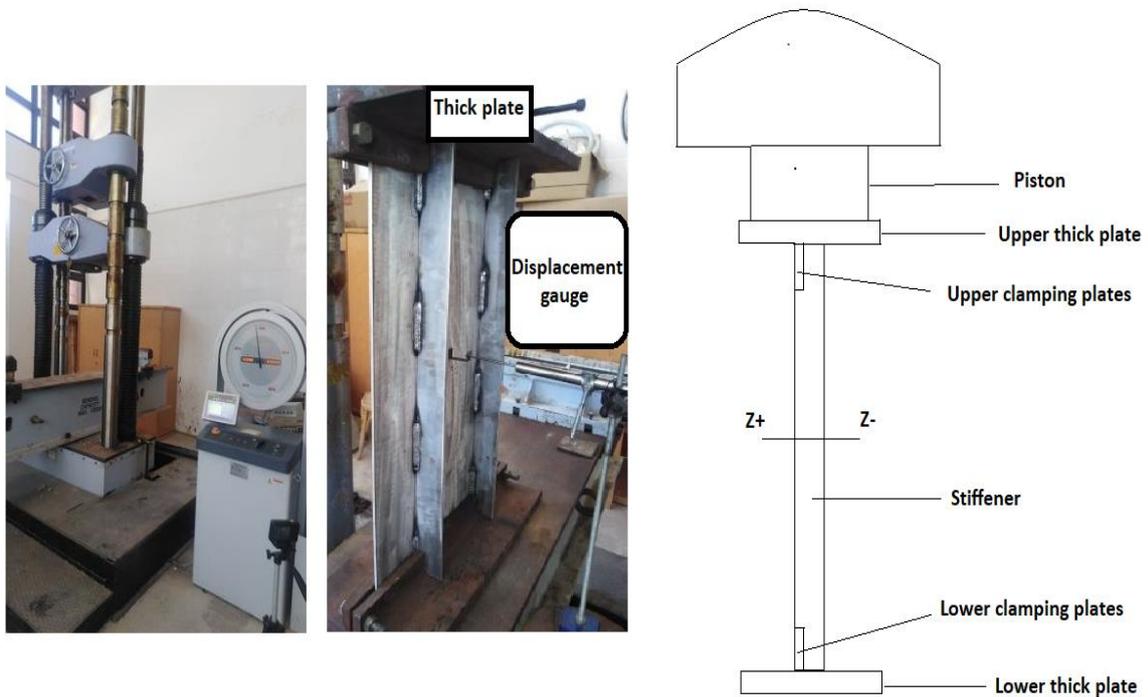
Figure 2: Experimental test setup, Structure and Concrete Research Laboratory, Faculty of Engineering, Port Said University

compressive test is to find out the ultimate compressive capacity of full-scale specimens which represent an actual part of large bilge strake panel in an existing pilot boat. A universal test machine with computerized system and capacity of 2000 kN is used for conducting the compressive test as shown in [Figure 2](#). An arrangement similar to that adopted by Saad eldeen et al. [3] has been applied, where the panel specimen is located at the centre of the test machine between two heavy supporting clamps with a thickness and depth of 20mm and 50mm, respectively, designed with two gaps for the attached stiffeners to facilitate the replacement of the panels as may be seen in [Figure 2](#). The short edges of the panels are restrained within the depth of the supporting clamps using bolt connections. The supporting clamps are assumed to constrain rotation and lateral displacement throughout their depth. The test has been conducted with displacement rate of 0.016mm/s and both vertical displacement as well as the acting load is recorded by the testing machine. The applied load is transmitted to the tested panel a thick plate in order to insure the uniform distribution of the acting load. An additional mechanical displacement gauge is fitted on the centre of the specimen for measuring the lateral displacement as presented in [Figure 2](#).

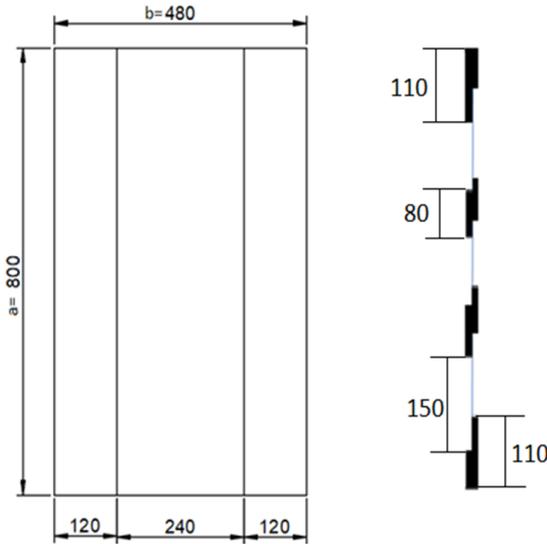
Figure 3: Basic geometry of the tested panel.

The basic geometrical configurations of the tested panels shown in [Figure 3](#) are part of real pilot structure, where the plate thickness is 6 mm with two flat bar attached stiffener 60×6 mm by means of fillet staggered welding. Both plates and stiffeners are fabricated from wrought aluminium alloy 5083-H116 and GMAW technique is used for the welding process with 1.2mm diameter electrode wire fabricated from aluminium alloy 5653. According to the geometrical configurations as well as the real mechanical properties, the plate and column slenderness of the panel are 2.74 and 0.526 respectively,

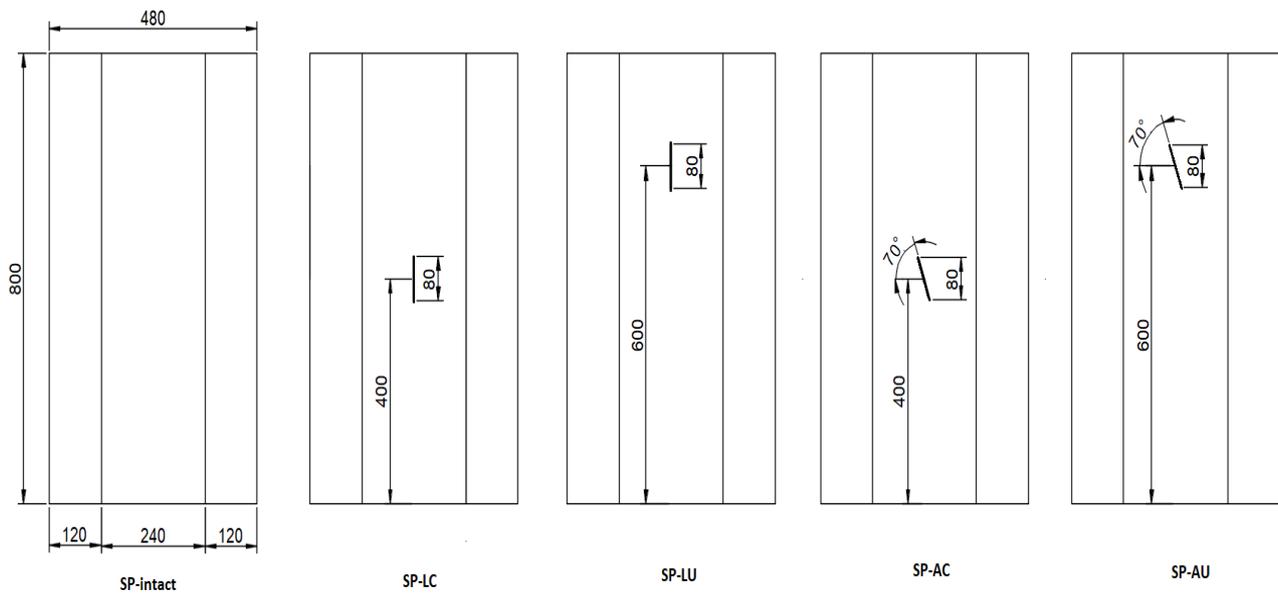
Figure 4: Geometrical configuration of the tested aluminum stiffened panels

As given in [Table 2](#) and [Figure 4](#), the panel specimens are denoted as SP-intact for intact panel (no cracks), SP-LC panel with longitudinal/central crack, SP-LU panel with longitudinal/upper quarter crack, SP-AC panel with angular /central crack and SP-AU panel with angular/upper quarter crack. Before conducting the collapse tested of the welded aluminium panels, a survey of initial imperfection measurements has been performed.

The crack for the present panel is a longitudinal crack of length 80 mm and located at the upper quarter of the panel SP-LU, as described in Figure 4 and Figure 10. Before the compressive test, the measured initial imperfection indicates that it is of symmetric shape with different amplitudes of 8 and 10 mm for w_1 and w_2 , respectively, as given in Table 3 and shown in Figure 5. As may be seen from Figure 10, the panel failed with inward deformation of both stiffeners near the lower clamp and far from the location of the crack without triggers of welding damage. Also, it may be noticed that the first stiffener S1 tripped inward with higher amplitude than the second stiffener S2. Therefore, it is evident that the final collapse mode of such panel is asymmetric. This deformed shape in addition to the undamaged welding affect directly the total capacity of the panel, where a high load carrying capacity of 504.8 kN is registered, with relevant shortening displacement of 3.32 mm, as presented in Figure 11 (left). After reaching the ultimate load, a sharp discharge of the capacity occurs without any recovery. Figure 11 (right) represents the relationship between the applied load and the developed lateral displacement at the center of the panel, it is clear that from the beginning of loading the central part between the two stiffeners deformed upward with lateral displacement related to the ultimate capacity of 0.1mm.

For this panel, the central crack is oriented with $\theta=70^\circ$ as shown in Figure 4, and before loading the geometrical imperfection of the plating is of symmetric shape, but the amplitude is different; $w_1=4$ mm and $w_2=7$ mm, see Table 3. As may be seen from Figure 12, the panel collapsed asymmetrically in both plating and stiffeners, resulting in higher ultimate compressive capacity of 508 kN. During the test, cracking weld damage was noticed for

For the current panel SP-AU, the crack is located at the center of the upper quarter of the panel with $\theta=70^\circ$ of orientation as described in Figure 4. The developed collapse mode of the panel is asymmetric including plate and stiffeners see F, regardless of the symmetric initial imperfection shape and amplitude of 8 mm as reported before the compressive test, see Table. As may be seen form F, (left), the deformation occurs at the frontier plate near the center of the panel and beneath the first stiffener S1, which forces S1 to trip outward and reach the ultimate capacity of 446 kN as presented in F (left). After that the capacity discharged with capacity reserve at 320.4 kN

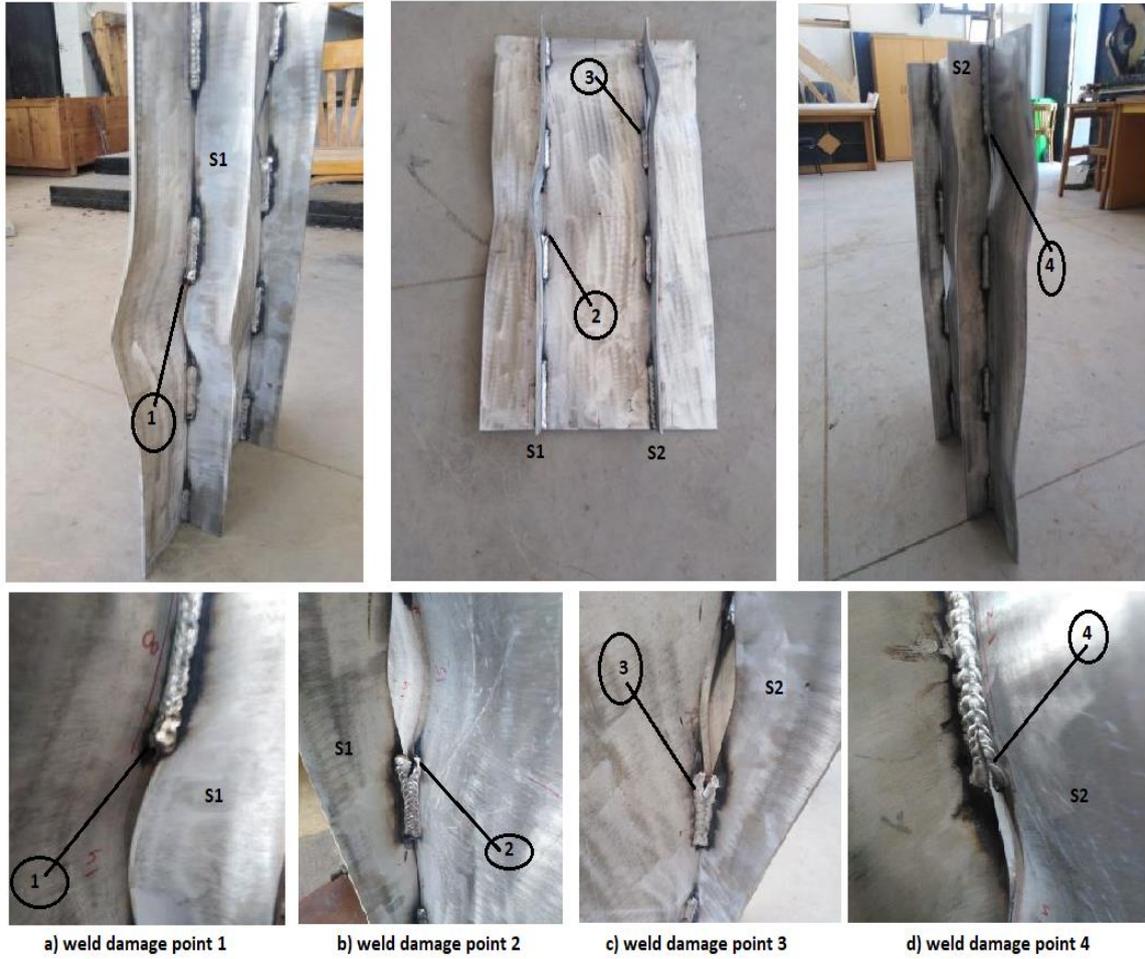
Figure 6: Collapse shape of the intact panel

5 and Table 2, where the plate between the attached stiffeners is almost flat. The collapse mode for the intact panel is shown in F. The collapse is reached at an ultimate load of 430.4 kN as shown in load-shortening curve Figure (left). It may be noticed from F that both stiffeners registered out of plane deformation (outward). The reason for such deformation is the failure of the plate at such specific location represented by downward deformation that forces the stiffener to buckle outward. This results in welding damage and plate separation as may be seen from the specimen details at point (1,2) for the first stiffener S1 and points (3,4) for the second stiffener S2, see Figure 6. This failure mode results in a gap between the plate and the attached stiffeners. It may be noticed that the final deformed shape of the plating is complex and asymmetric. The registered axial displacement by the testing machine as well as the applied load is presented in Figure 7 (left), in which the pre-buckling regime ends at 166 kN with shortening displacement 0.69 mm. The intact panel, SP-intact registered ultimate compressive capacity of 430.4 kN with corresponding axial shortening displacement 3.48mm. Based on the recorded lateral displacement during the experiment using a mechanical displacement gauge mounted at the mid-length-breadth of the specimen, the relationship between the axial load and the lateral displacement is presented in Figure 7 (right). It may be noticed that from the beginning of loading the middle portion of the panel buckled in the upward direction with a lateral displacement of 4.7 mm with respect to the ultimate load carrying capacity.

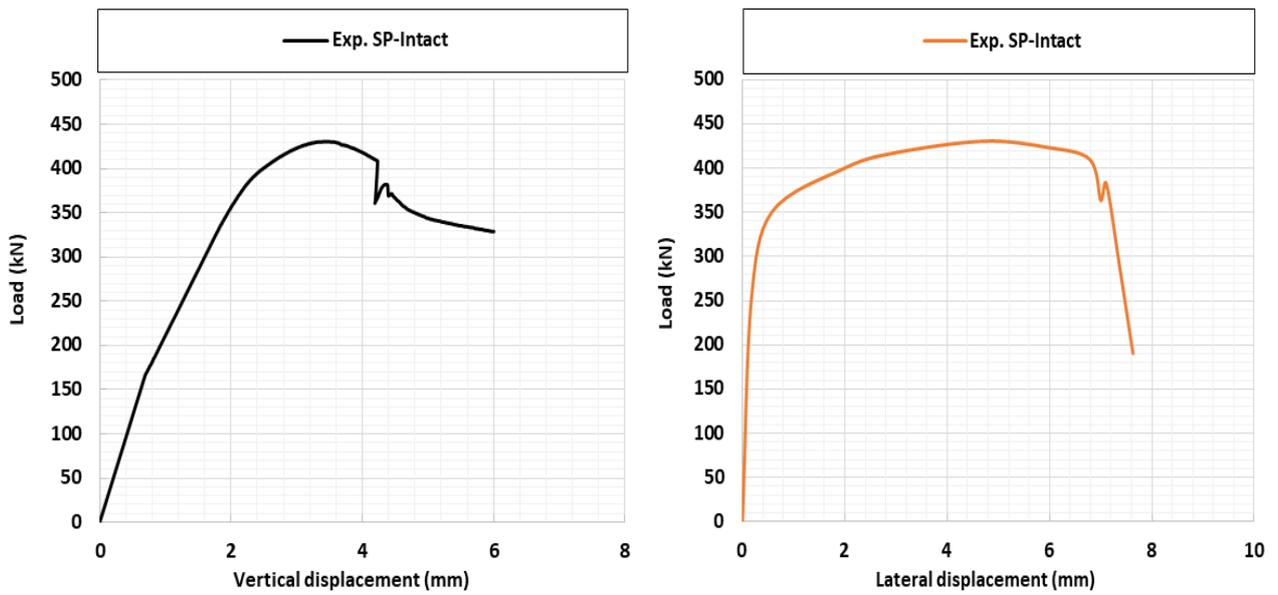
Figure 7: Load shortening (left) and load-lateral displacement (right), SP-intact

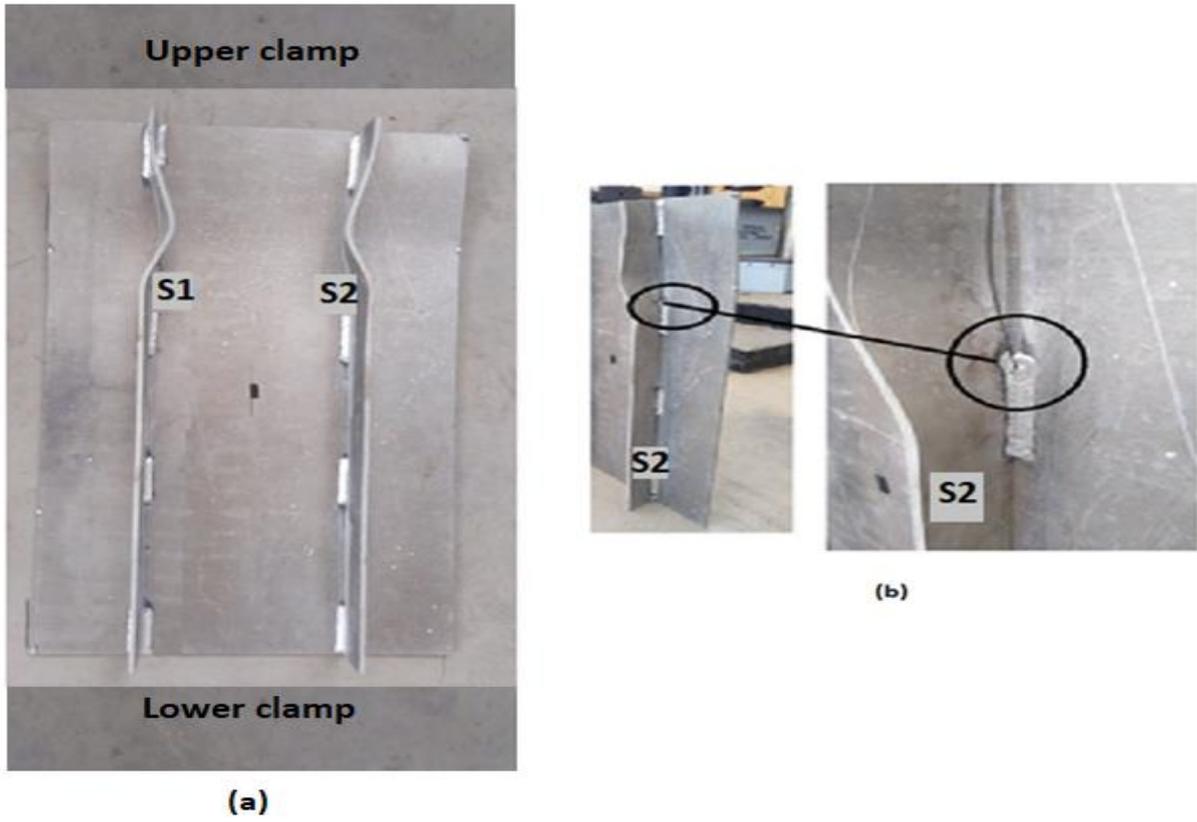
Figure 8: Collapse shape of SP-LC

The panel specimen SP-LC has a longitudinal central crack in the direction of loading with length of 80 mm. The initial imperfection shape is symmetric with imperfection amplitude of 14 mm as given in Table 3. The final collapse mode after removing the applied load is shown in Figure 8. It may be noticed that the deformed shape of the stiffeners is symmetric with inward tripping, which results from the downward buckling of the plate between the attached stiffeners. This is followed by welding damage of stiffener S2 at the location shown in Figure 8 and on contrary, no welding damage occurs for the first stiffener S1. It may be noticed that the developed deformation for both plating and stiffeners occurred far from the existing crack and close to the upper clamp, which may result in lower axial compressive capacity of 379.72 kN, in addition to the higher symmetric initial imperfection of 14 mm, which may facilitate the

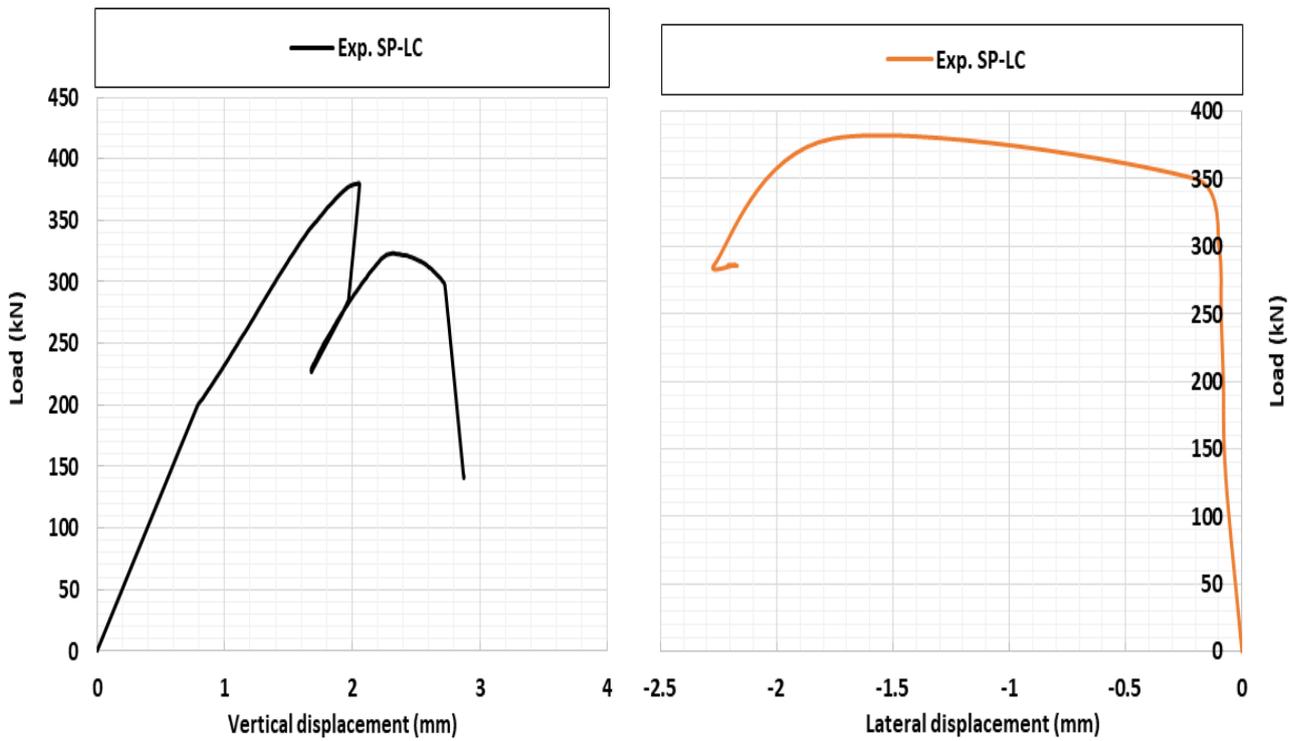
Figure 9: Load shortening (left) and load-lateral displacement (right), SP-LC

occurrence of earlier buckling. The developed vertical displacement; shortening with respect to the applied load is shown in Figure 9 (left), where the panel SP-LC recorded ultimate compressive capacity of 379.72 kN, with shortening displacement of 2.04 mm. It may be noticed that the elastic response of the panel ends at 199.07 kN with corresponding displacement of 0.79 mm. As may be seen in Figure 9 (left) a sudden decrease in the load carrying capacity occurred simultaneously with the failure of the plate to withstand the applied load, followed by welding damage and then stiffeners tripping.

Figure 9 (right) represents the relationship between the measured lateral displacement using the displacement gauge and the acting load, it is evident that the middle portion of the panel SP-LC at which the measurements are recorded buckled downwards from the beginning of loading, recording lateral displacement at the ultimate loading capacity of -1.76mm.

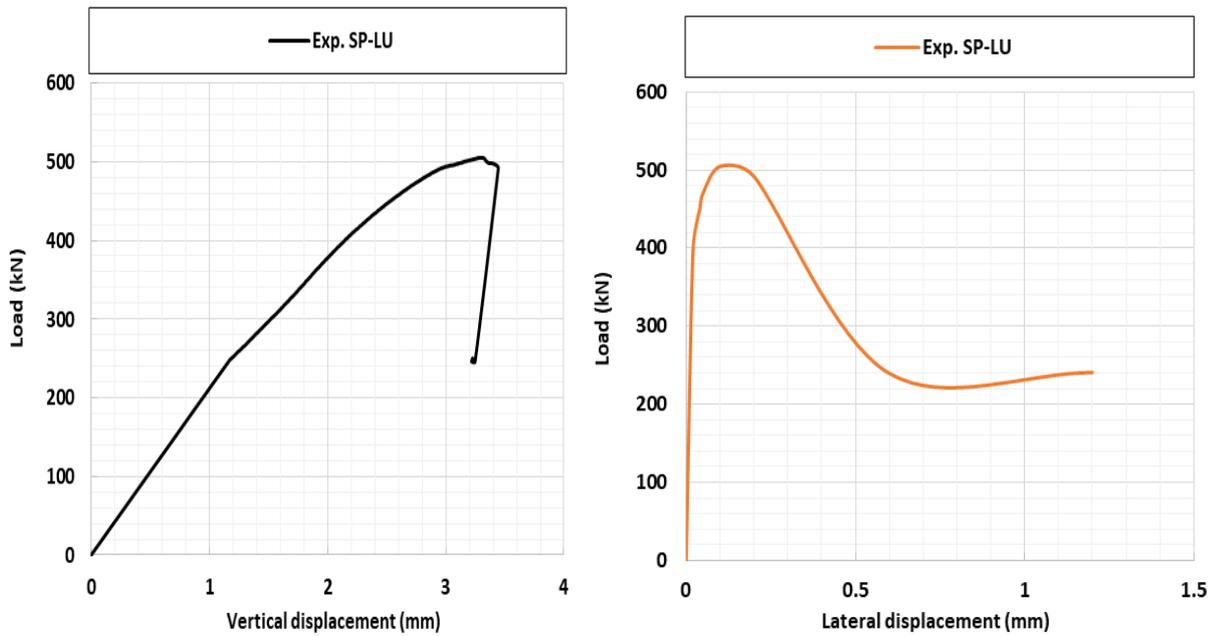
Figure 11: Load shortening (left) and load-lateral displacement (right), SP-LU

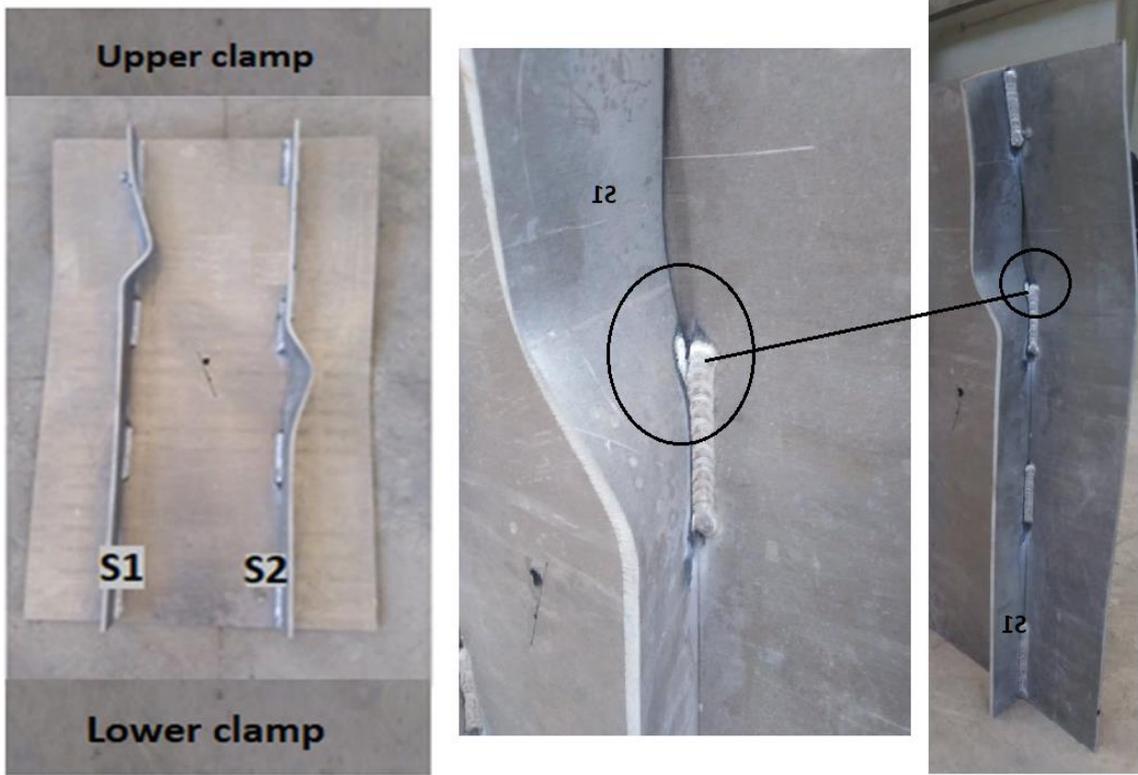
Figure 12: Collapse shape of specimen SP-AC

stiffener S1 as presented in F, due to the failure of the plate to withstand the applied load near the upper clamp, which forces S1 to deform. After that the second stiffener S2 failed to carry the acting load, and responded with outward tripping at the mid-span of the panel aligned with the crack. The load-shortening relationship is presented in Figure 13 (left), where the global elastic behavior of SP-AC panel ends at acting compressive load of 240.4 kN, with elastic shortening of 1.08 mm. After that the permanent deformation of the plate beneath the S1 at the location of damage presented in F occurs, which forces the panel to a partial loss of capacity after reaching the ultimate load at 508 kN, followed by plate resistance to the applied load, until the second stiffener tripped outward at a lower load of 499.2 kN with maximum amplitude aligned transversely with the crack location, as may be seen in Figure 13 (left). The lateral response of the plate between the attached stiffeners is presented in F (right) by the lateral displacement versus the acting load.

It is evident that till 400 kN, no change with respect to the original initial imperfection of the middle portion is registered. At the ultimate load, the panel registered a slight upper deflection of amplitude 0.01 mm and increases with increasing the capacity discharge. This may be explained by the contribution of the angular central crack to the stability of the middle portion until the second stiffener S2 and the corresponding plate failed to withstand the applied load, see Figure 12.

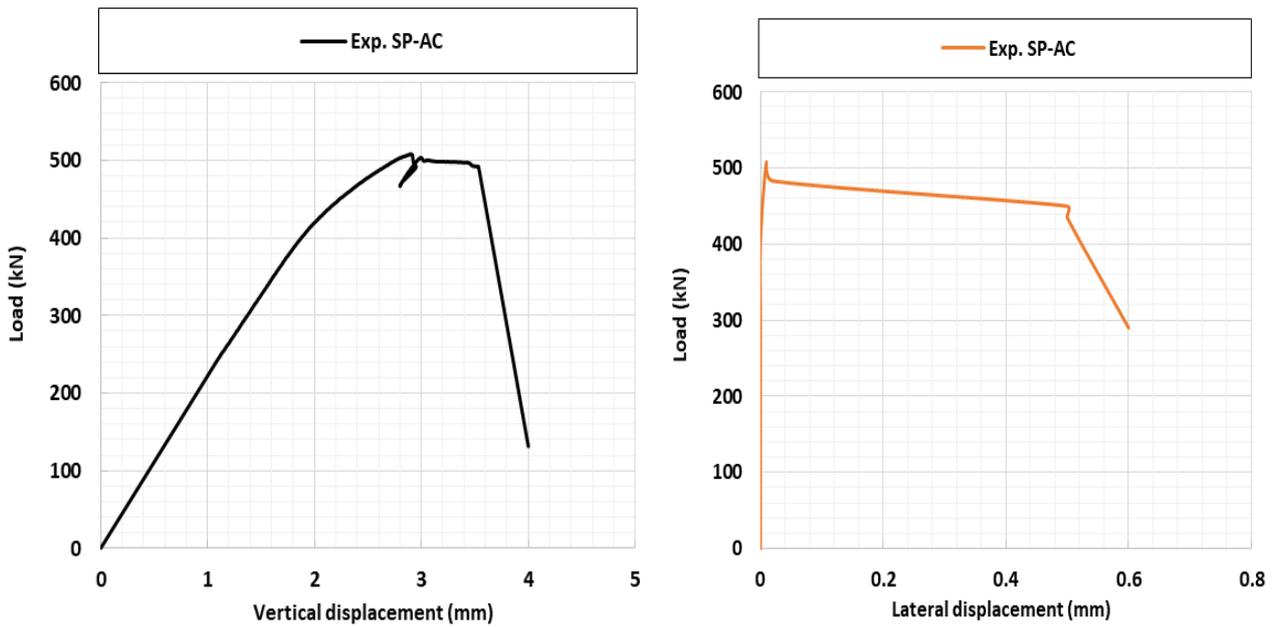
Figure 13: Load shortening (left) and load-lateral displacement (right), SP-AC

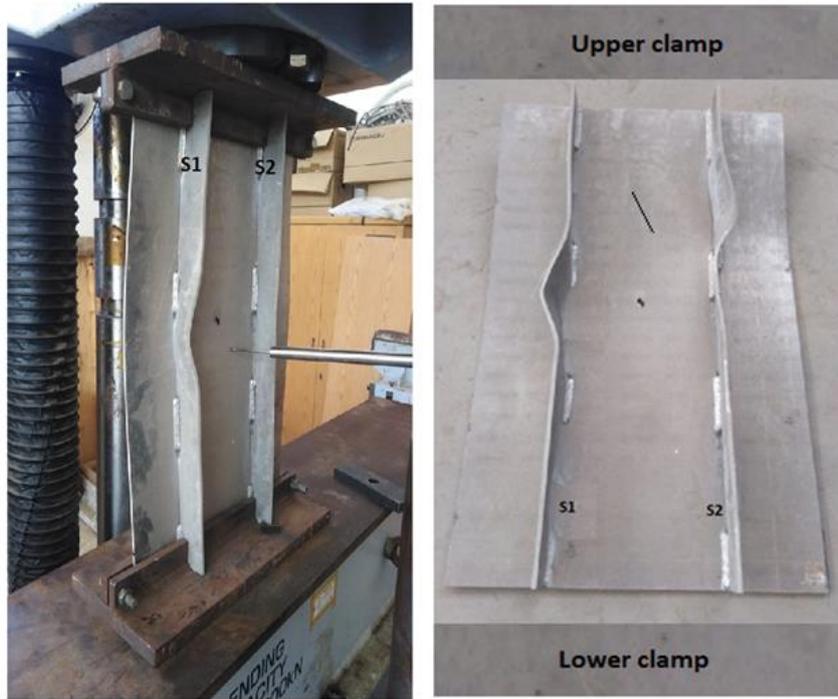
Figure 14: Collapse shape of specimen SP-AU during the test (left) and after (right).

until the progressive collapse of the second stiffener S2 in line with the angular crack location and near the upper clamp occurred, followed by plate buckling, see Figure 14, (right) and failure of the panel. It has to be stated that despite the absence of welding damage, SP-AU panel registered lower load carrying capacity compared to the panel with angular central (SP-AC) which reported welding damage as shown in Figure 12. The reason may be related to the difference in the initial imperfection shape of both panels, noting that SP-AU has a symmetric imperfection shape which is considered to be the weakest shape of the initial imperfection to resist the compressive load as concluded by [16]. Also, the occurrence of damage near the upper clamp and close to the crack location may decrease the structural capacity of the panel as noted in SP-AU. The relationship between the lateral displacement and the acting vertical load is presented in Figure 15 (right), in which the location of the mechanical displacement gauge shows upward lateral displacement with some disturbance between 132 kN and 246 kN, which is the end of the elastic regime. After that the lateral displacement increases as the acting load increases, registering lateral displacement with respect to the ultimate capacity on 1.48 mm.

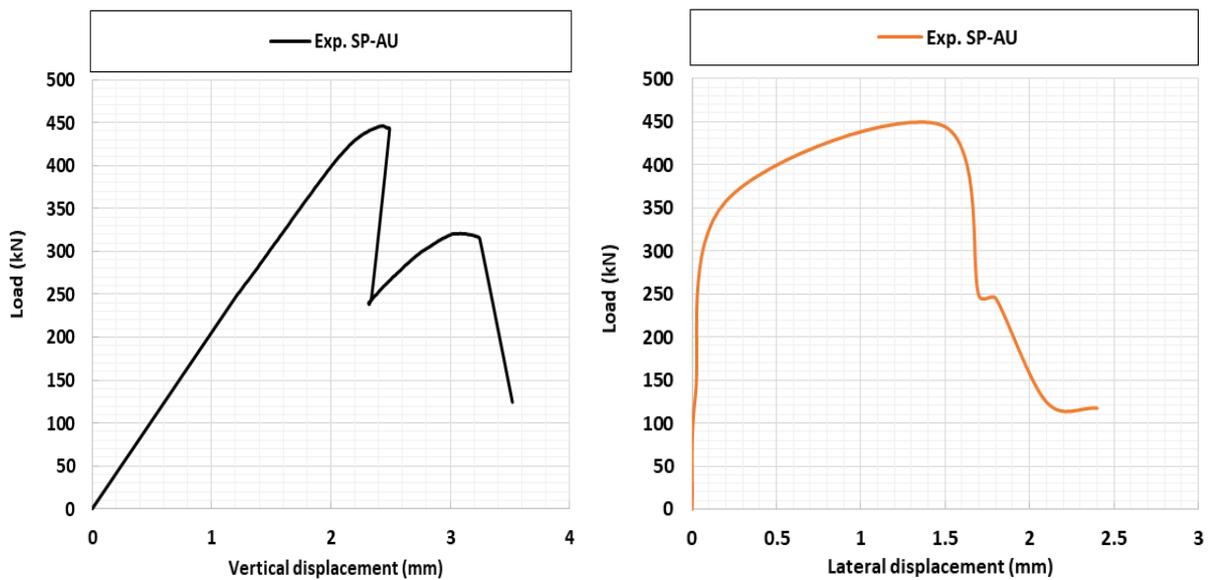
Figure 15: Load shortening (left) and load-lateral displacement (right), SP-AU

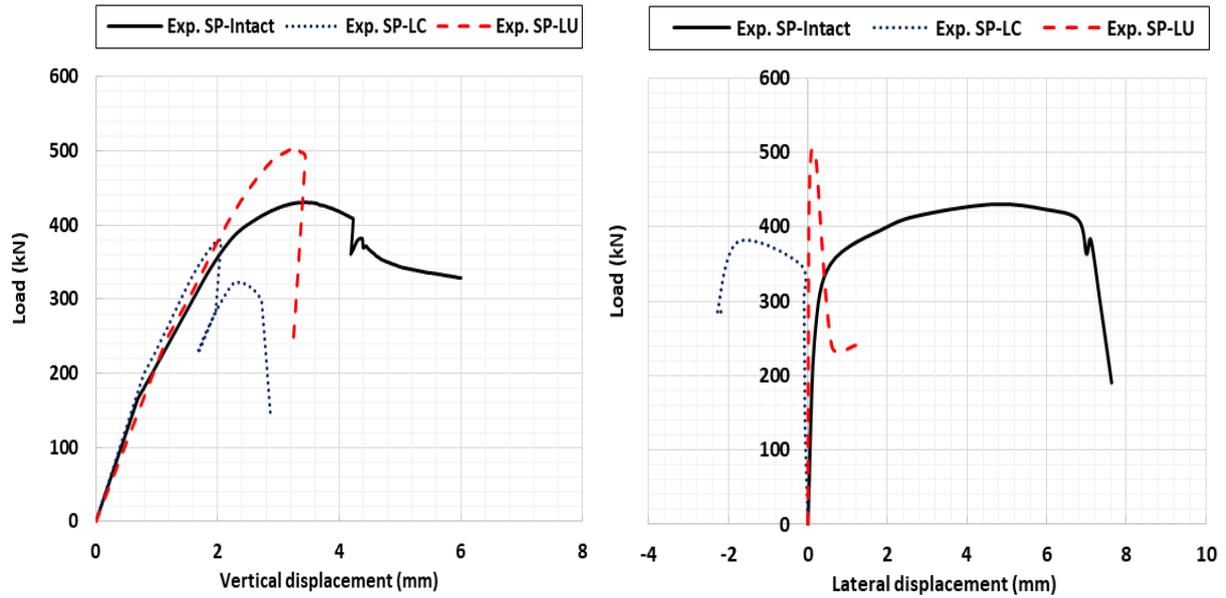
Figure 16: Load-shortening (left) and load-lateral displacement (right), considering different crack locations

In this subset of the analysis, the effect of the crack location on the ultimate compressive capacity as well as on the collapse mode will be discussed for SP-Intact, SP-LC and SP-LU. The load-shortening curve for the three panels is presented in Figure 16 (left), with the corresponding ultimate values in Table 4.

From ultimate capacity point view, it appears that both panels SP-LC and SP-LU registered different responses with respect to SP-Intact, where SP-LC collapsed with lower capacity than the intact one by 11.78%, on contrary to SP-LU, where higher capacity than the intact one was registered by 17.29%, see Figure 16 (left) and Table 4. The primary reason for such difference responses may be due to the initial imperfection, where the panel SP-LC had a high plating symmetric amplitude 14 mm; this panel developed a final downward lateral central displacement of -1.76 mm, that facilitates the earlier capacity discharge, in

addition to the occurrence of stiffeners tripping near the upper clamp, with a shortening displacement of 2.04 mm which is less than the intact one. On contrary, the capacity of the panel SP-LU seems to be enhanced by the asymmetric initial imperfection of amplitudes 8 mm and 10 mm; this remark is supported by the final upward lateral displacement of 0.1 mm, see Figure 16 (right), which is in agreement with the work done by Saad Eldeen et al. [3] who concluded that the sign of the imperfection amplitude as well cracks governs final the collapse shape and mode and provides more carrying capacity.

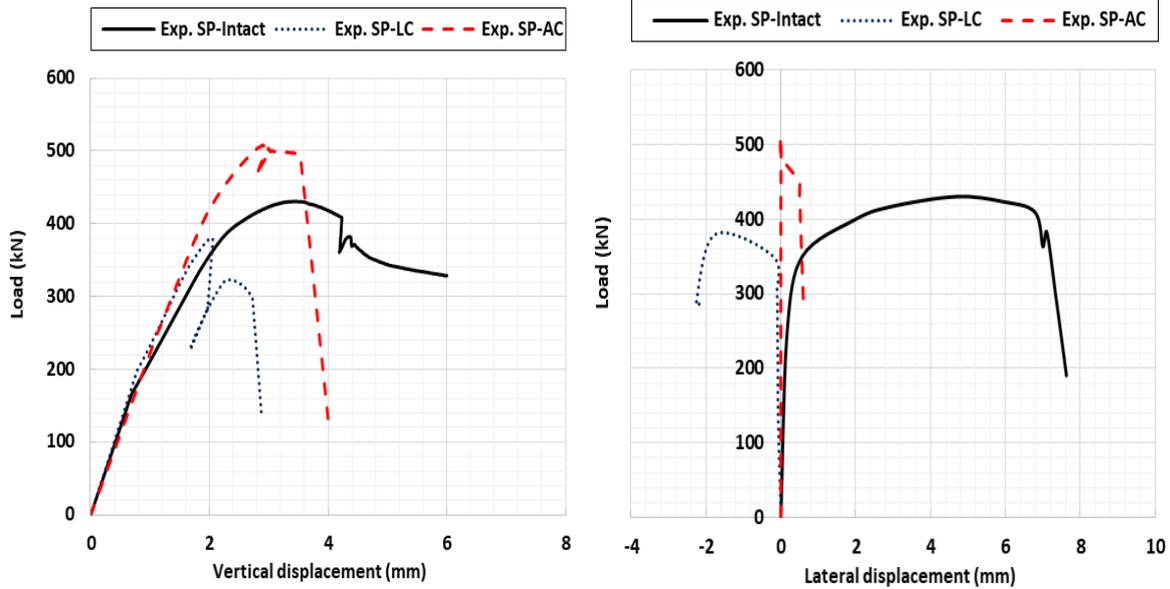
Figure 17: Load-shortening (left) and load-lateral displacement (right), considering central crack orientation

The response of the panels SP-LC and SP-AC for different central crack orientation with respect to the intact panel SP-Intact will be investigated. As may be seen from Figure 17 (left), both panels behave in different manner with respect to the intact panel as previously stated for different crack location. For SP-AC panel with crack orientation $\theta=70^\circ$, the ultimate capacity is higher than the intact one

by 18.03%, see Table 5, which may result from the asymmetric initial imperfection amplitudes of 4 mm and 7 mm, which are less than both intact and SP-LC panels, followed by almost flat final lateral displacement 0.01 mm, see Figure 17 (right). It was noticed that, for SP-AC panel, the tripping of the second stiffener S2 is aligned with the angular crack creating an asymmetrical deformation of the two stiffeners.

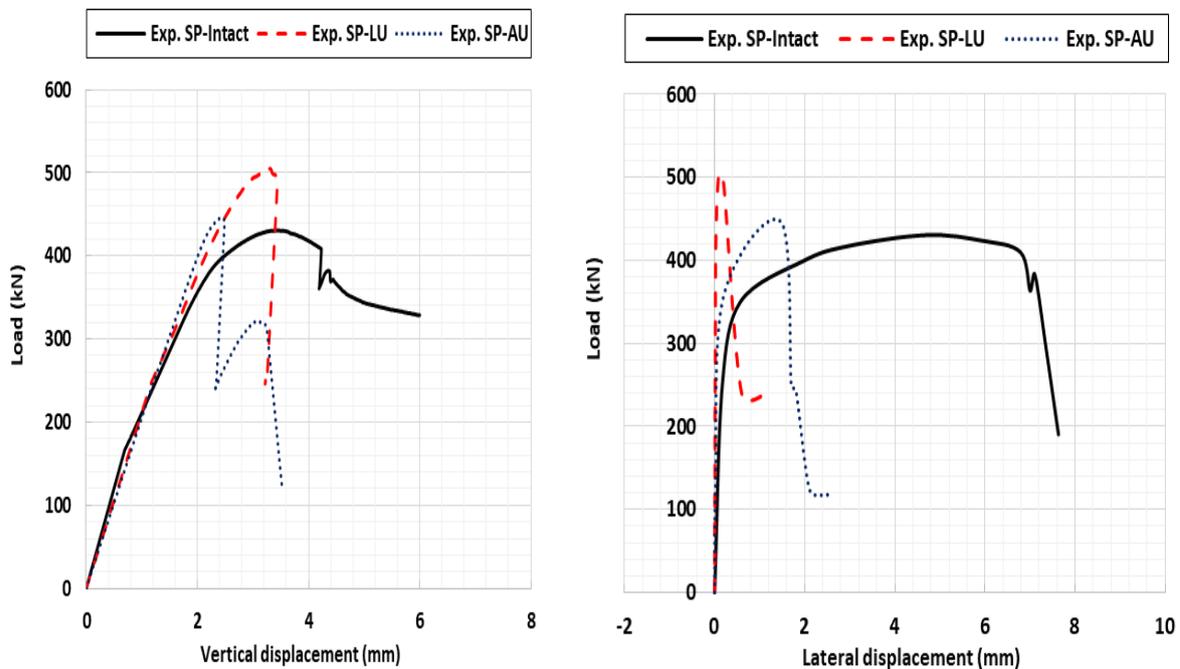
Figure 18: Load-shortening (left) and load-lateral displacement (right), considering upper quarter crack orientation

For this subset of the analysis, the response of the panel with locked cracks located at the upper quarter with different orientation SP-LU and SP-AU will be analyzed. It may be noticed that, both panels SP-LU and SP-AU withstand ultimate capacity higher than the intact one by 17.29% and 3.62%, respectively, see Figure 18 (left) and

Table 6, which is on contrary to the panels with central crack. For SP-AU panel, there are several remarks which result in higher capacity than the intact one as the less symmetrical imperfection amplitude of 8mm, compared to the intact panel of 10 mm. Also, the less developed final lateral displacement of 1.48 mm, where the intact one is 4.47 mm as presented in Figure 18 (right). Furthermore, no welding damage occurs for SP-AU, but for the intact panel, four locations of welding damage were reported as may be seen from the collapse shape in Figure 6, which directly affects the capacity of the intact panel. From stiffeners

The increase in their load-carrying capacity may be related to the state of initial imperfections which is known to be of predominant effect [16]. The comparison of all values and curves does not indicate clear relationships regarding the location and orientation of the cracks produced.
